Report of Dam Safety Assessment of Coal
Combustion Surface Impoundments
American Electric Power (AEP) and Southwest
Electric Power Company (SWEPCO)
H.W. Pirkey Power Plant, Hallsville, TX

AMEC Project No. 3-2106-0183.0003

June 2011

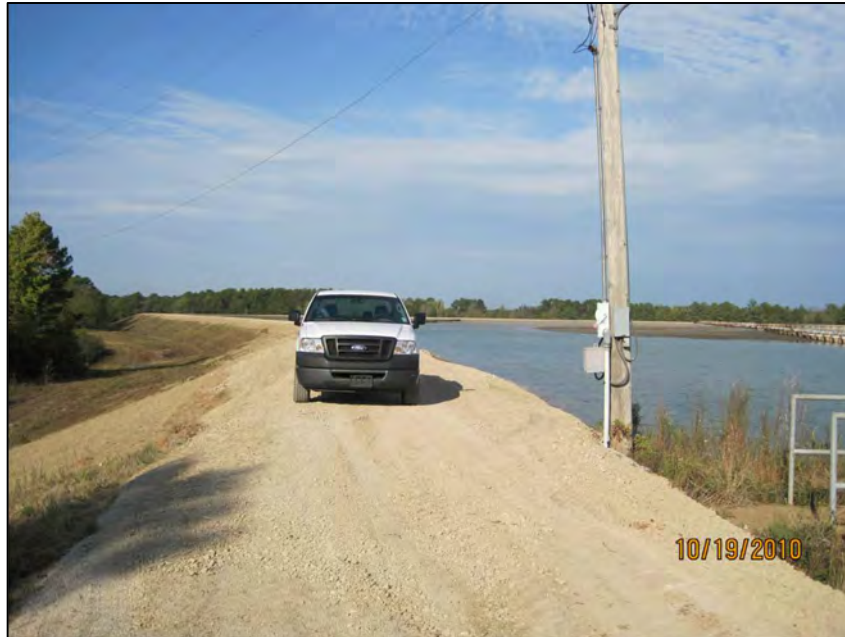
WAP-1
CREST AT SOUTHEAST CORNER CREST LOOKING WEST

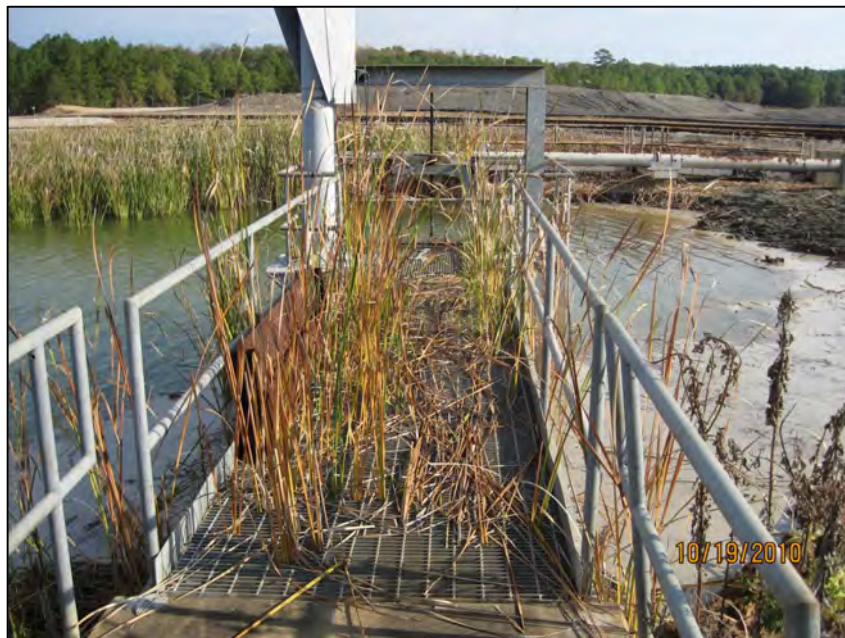
WAP-2
TOP OF DISCHARGE STRUCTURE

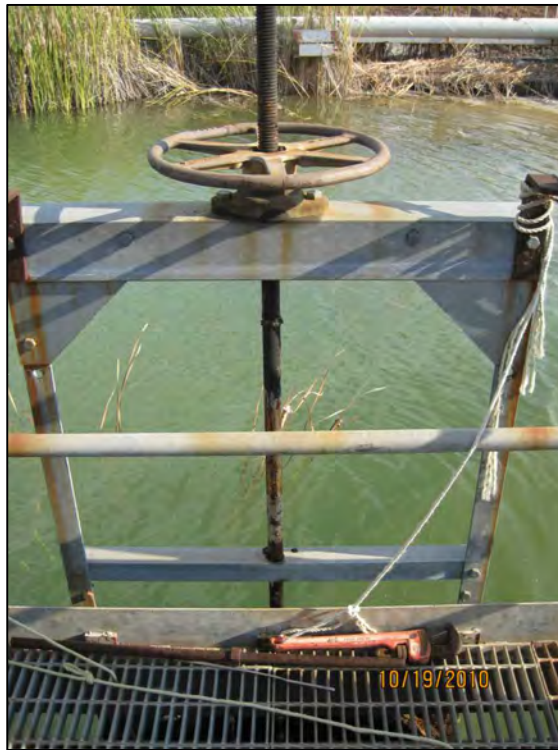
WAP-3
DISCHARGE PIPE VALVE OPERATOR

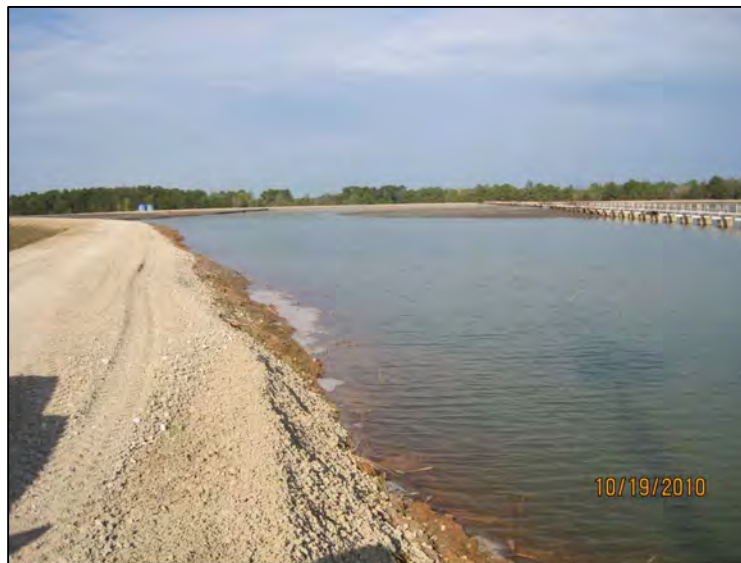
WAP-4
UPSTREAM SLOPE AT SOUTHEAST CORNER LOOKING WEST

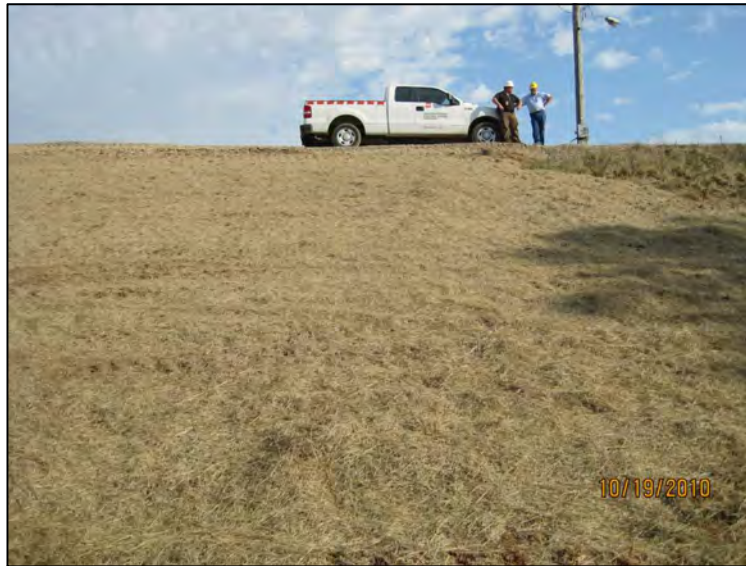
WAP-5
LOOKING NORTH UP DOWNSTREAM SLOPE AT SOUTHEAST CORNER

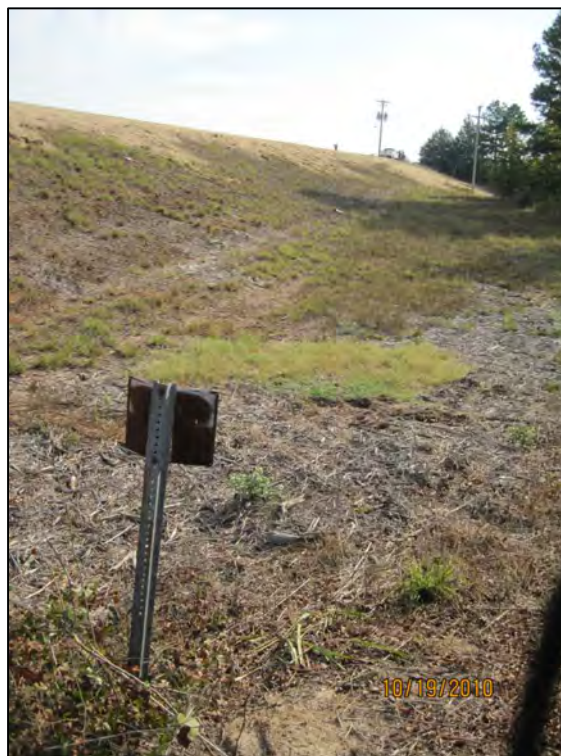
WAP-6
LOOKING EAST ON SOUTH DOWNSTREAM EMBANKMENT

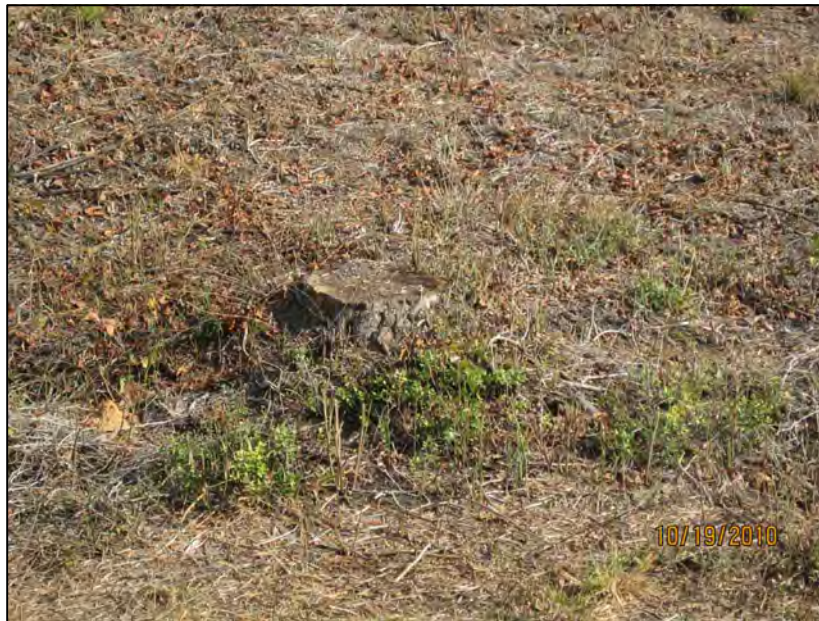
WAP-7
STUMP ON SOUTH EMBANKMENT

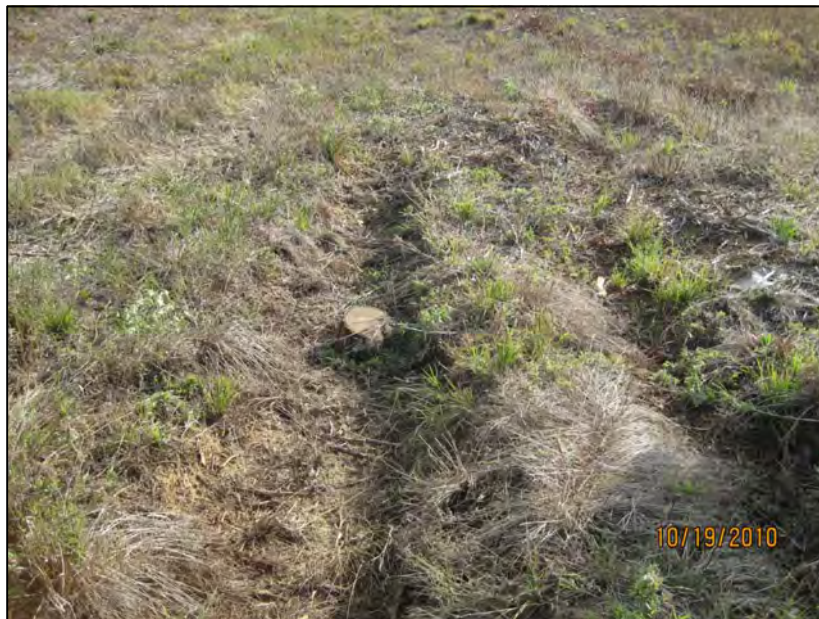
WAP-8
RUTS AND STUMP ON SOUTH EMBANKMENT

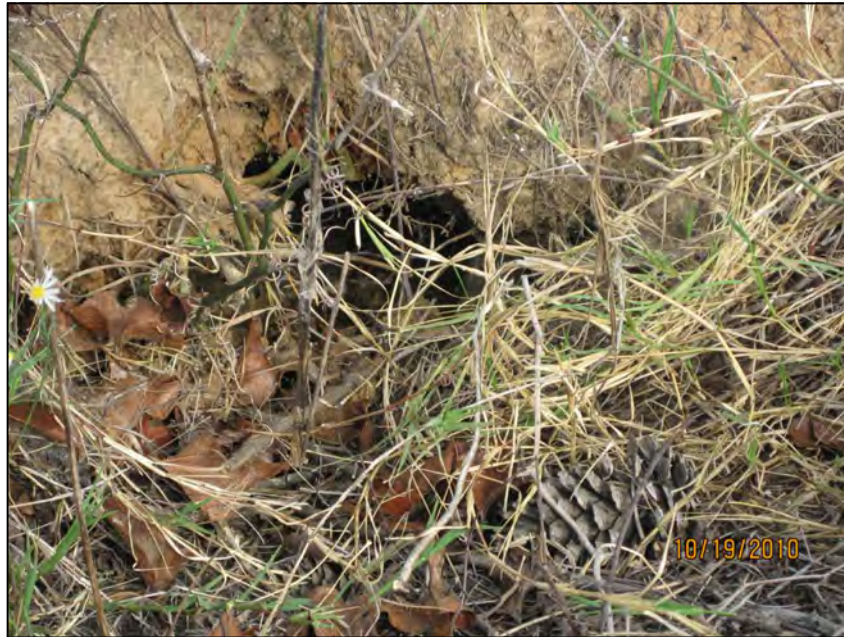
WAP-9

ANIMAL BURROW ON SOUTH DOWNSTREAM EMBANKMENT

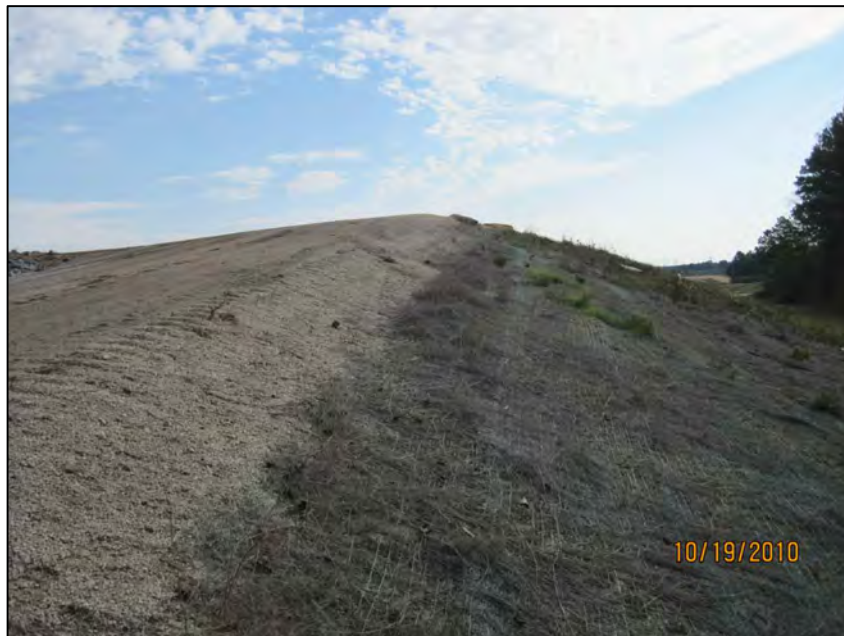
WAP-10

SURFACE EROSION AT SOUTHWEST EMBANKMENT CORNER

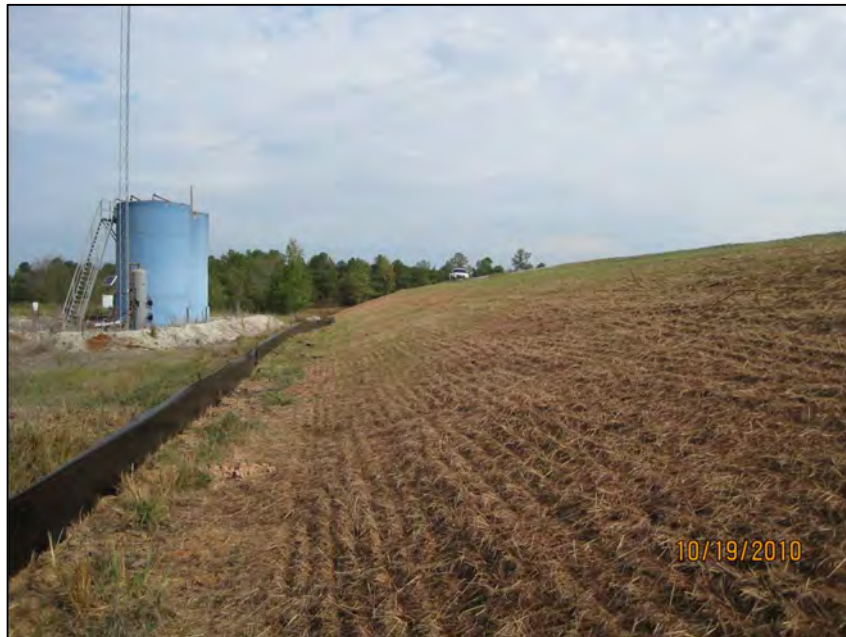
WAP-11
LOOKING NORTH ALONG WESTERN DOWNSTREAM
EMBANKMENT AT RECENT SURFACE WORK

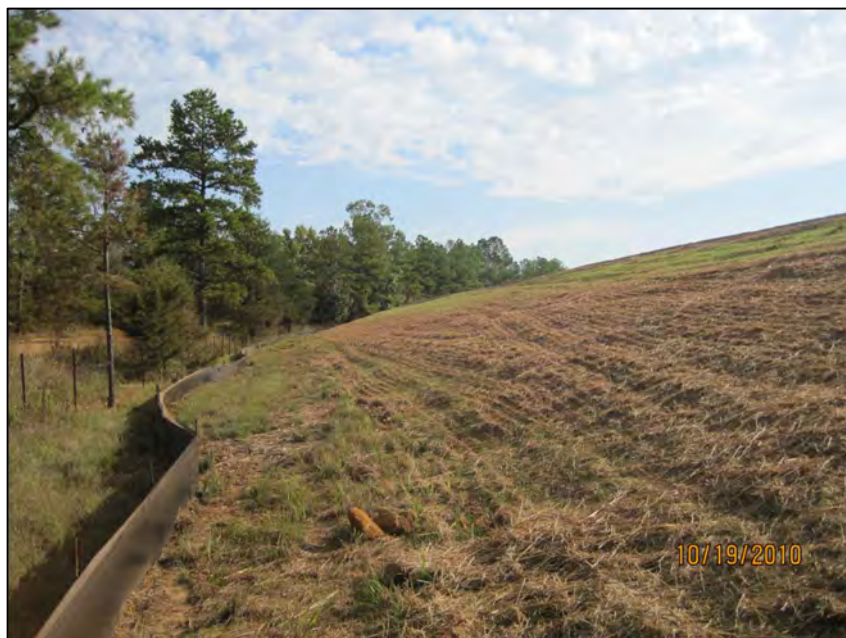
WAP-12
LOOKING NORTHEAST ALONG NORTHERN DOWNSTREAM
EMBANKMENT AT RECENT SURFACE WORK

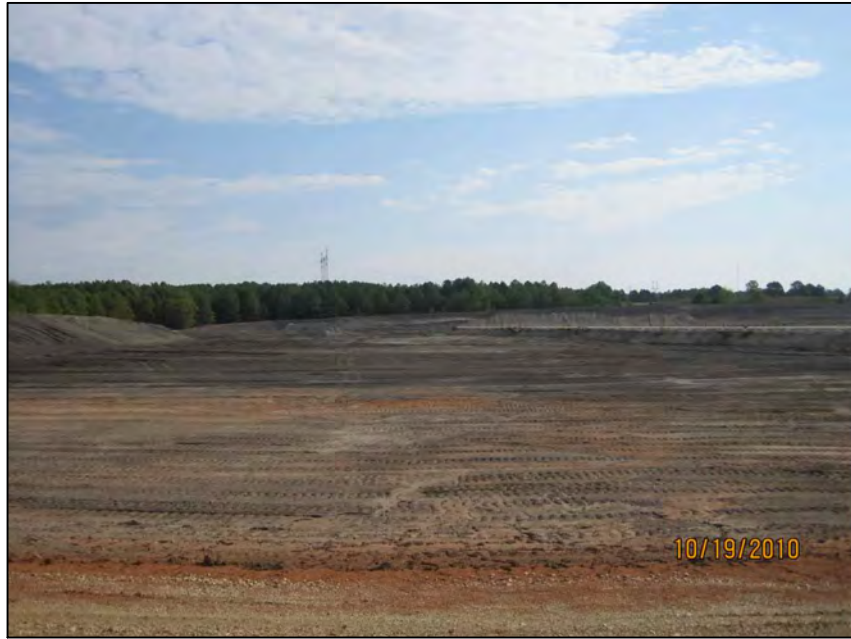
This pond is completely incised and was not in service during the site visit. Photos EAP-1, EAP-5, and EAP-6 show the interior of the East Ash Pond, as well as areas of stacked ash. A drainage swale, to redirect runoff flows away from the pond, exists outside the pond's southeast, east and north perimeter crest road. The crest road is gravel covered as shown on Photos EAP-2, EAP-10, and EAP-11. A piezometer was noted on the northwest crest road (Photo EAP-3). Photo EAP-8 illustrates a gas pipeline indicator located off the northeast crest road.

EAP-1
LOOKING EAST ACROSS POND FROM WESTERN CREST

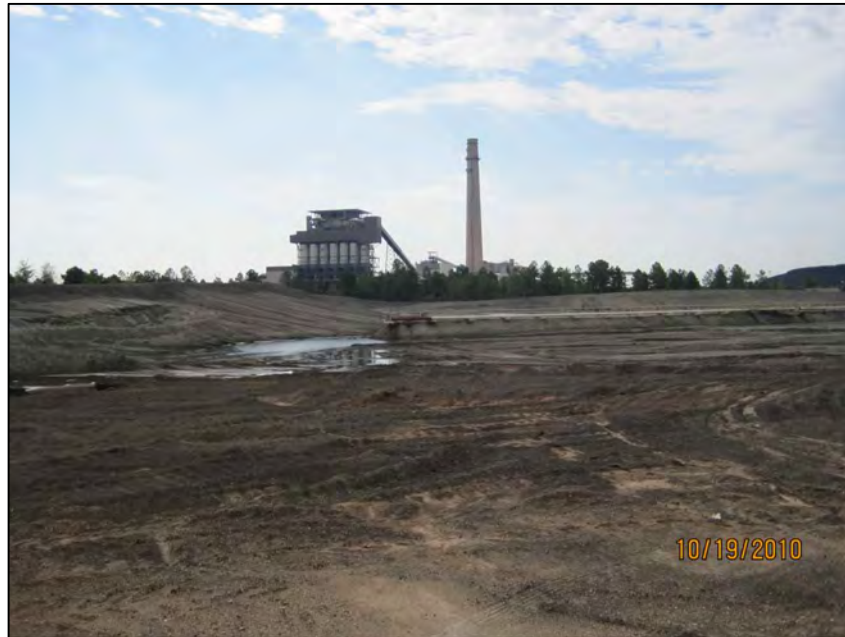
EAP-5
LOOKING SOUTH FROM NORTHERN EMBANKMENT

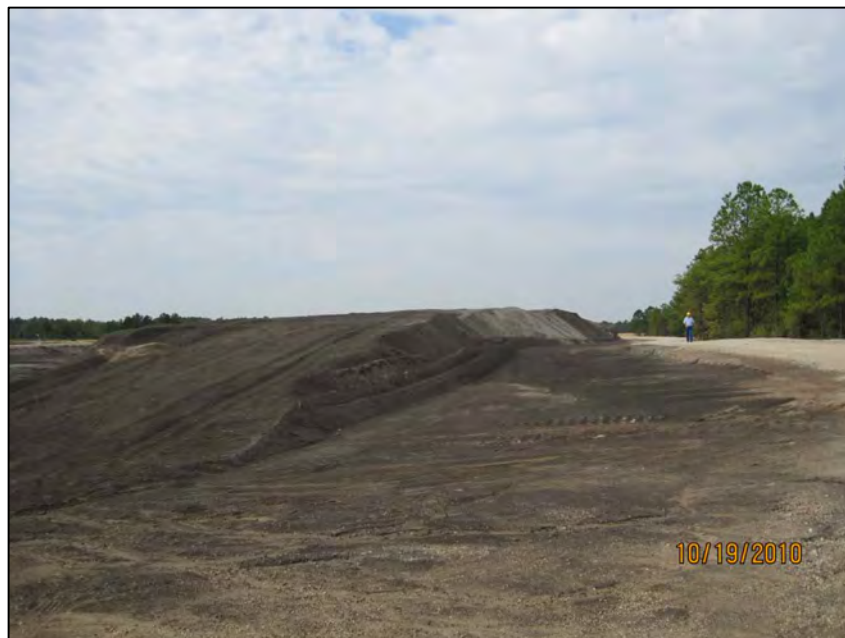
EAP-6
LOOKING SOUTHWEST FROM NORTHERN
EMBANKMENT AT STACKED ASH

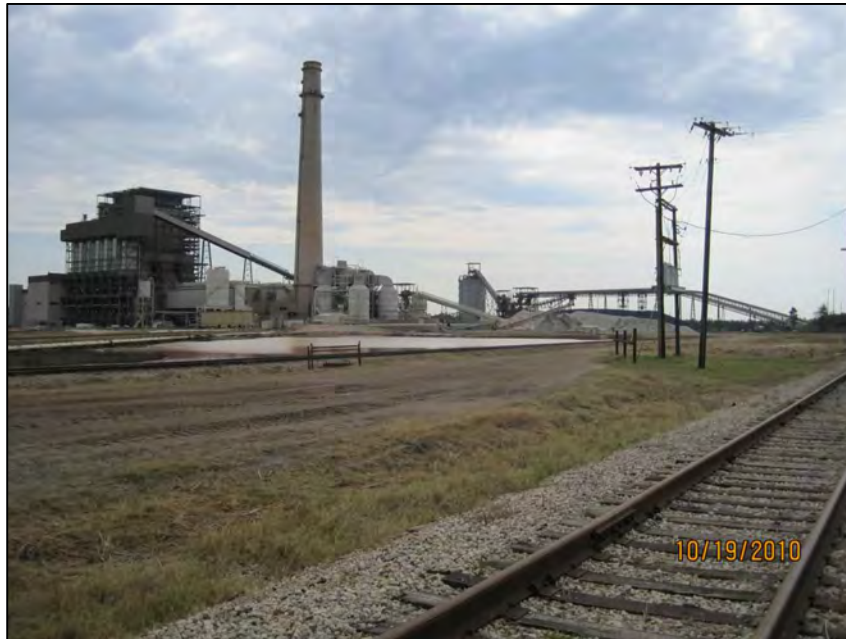
This pond is entirely incised. However, a road and railroad are located along its western boundary. The ground immediately to the west of the railroad slopes away steeply (Photos SP-1 and SP-2). Additionally, there is a below grade limestone unloading area beneath a portion of the railroad (Photo SP-3). A stormwater culvert was visible through the embankment south of the limestone unloading area (Photo SP-4). A monitoring well was noted at the southwest corner of the pond (Photo SP-5).

SP-1
RAILROAD TRACKS WEST OF SURGE POND-FROM
NORTHERN CORNER LOOKING SOUTHEAST

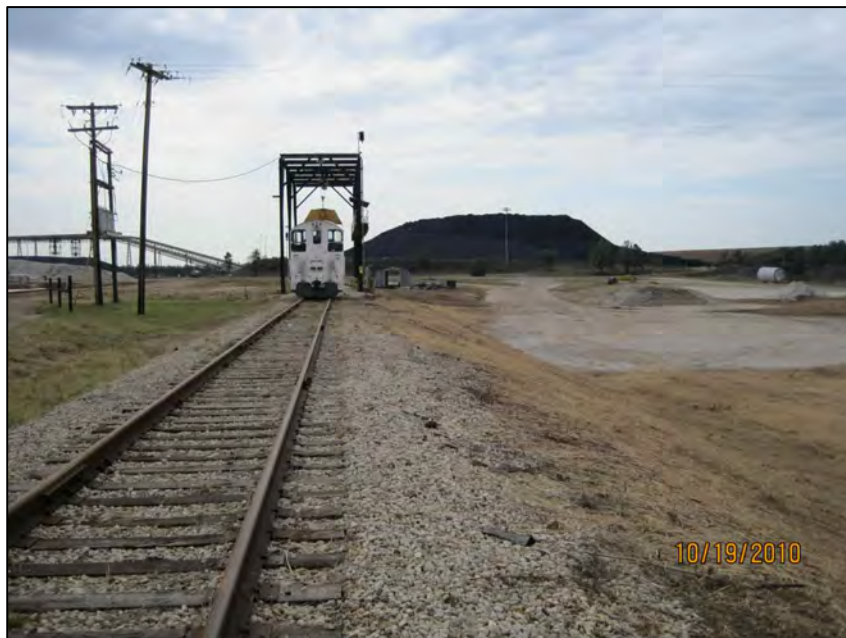
SP-2
NORTHWEST OF POND LOOKING
SOUTH AT LIMESTONE UNLOADING AREA

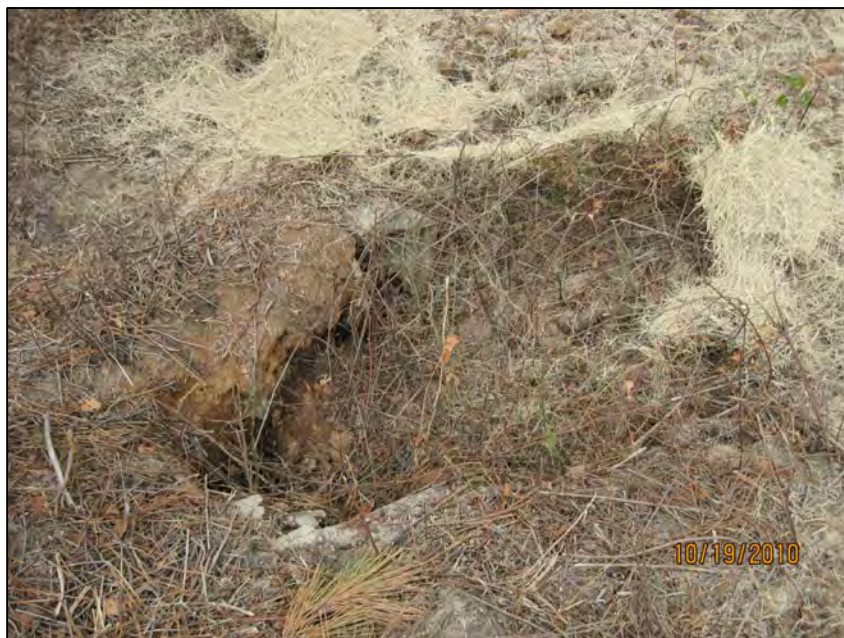
SP-4
STORM WATER CULVERT (18-INCH) THROUGH
EMBANKMENT SOUTH OF LIMESTONE UNLOADER

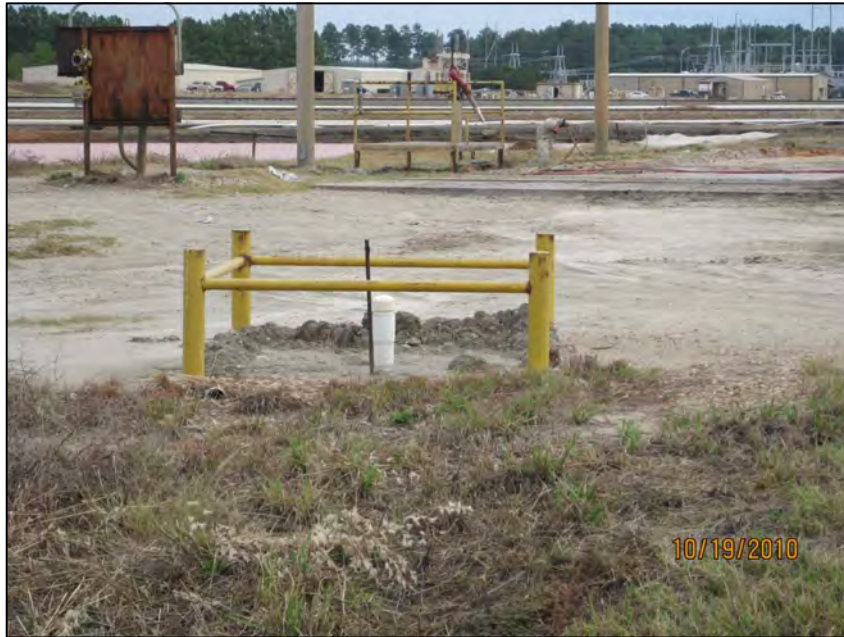
SP-5
MONITORING WELL LOCATED ADJACENT
TO SOUTHWEST CORNER OF POND

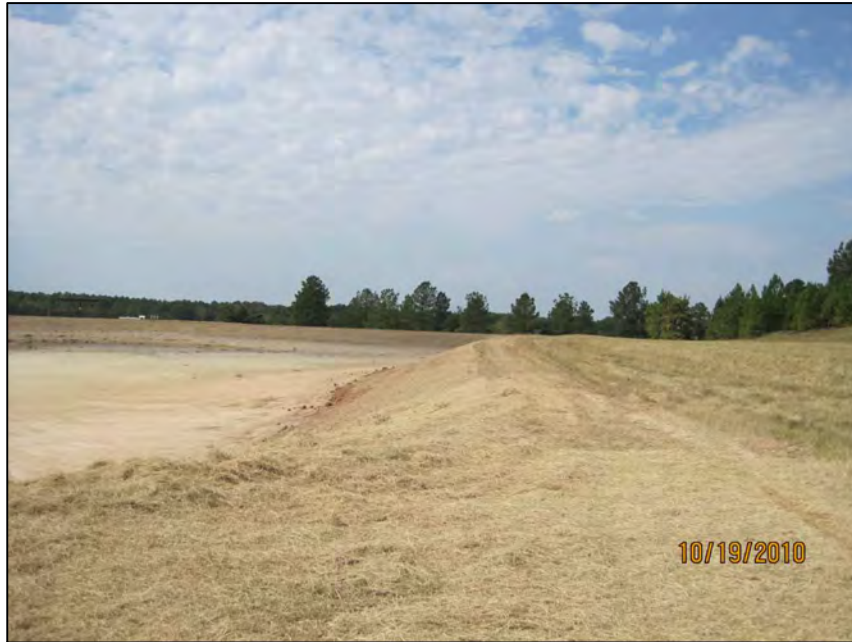
The northern portion of the Auxiliary Surge Pond is incised, while the remainder is diked (Photo ASP-1 and ASP-2). A piezometer was noted on the southwest corner of the pond embankment (Photo ASP-3).

ASP-1
LOOKING WEST FROM NORTHEAST
CORNER EMBANKMENT

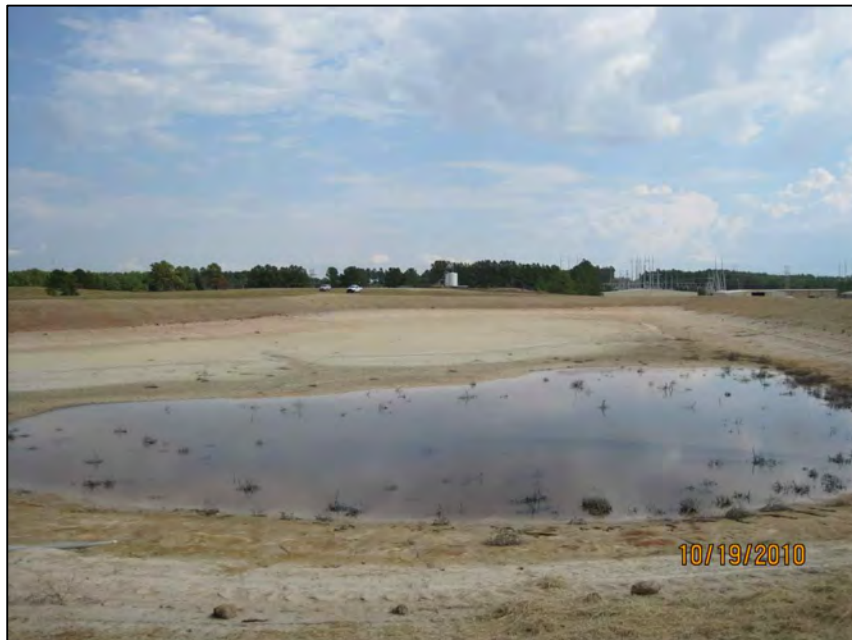
ASP-2
LOOKING EAST ACROSS POND
FROM WESTERN EMBANKMENT

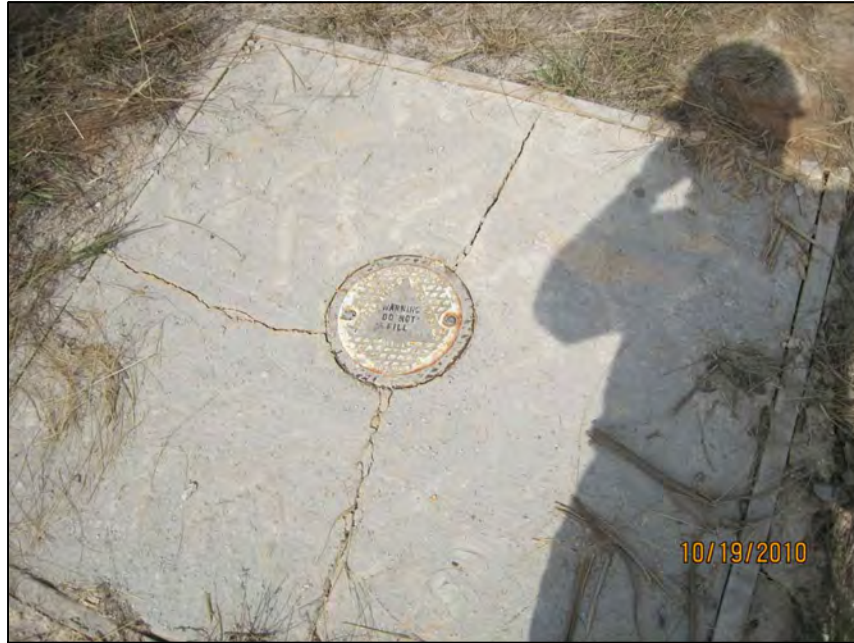
ASP-3
PIEZOMETER ON SOUTHWEST
CORNER OF POND EMBANKMENT

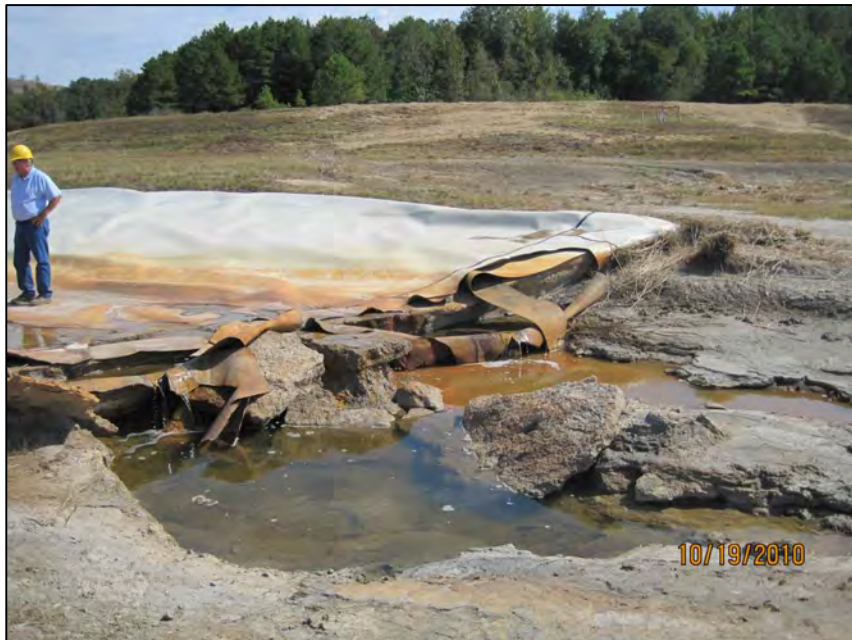
As shown on Photo LRP-6, flow enters the pond via a trapezoidal channel that is lined with 60-mil HDPE. A monitoring well was noted located to the southeast of the influent channel above the northern reach of the pond (Photo LRP-7).

LRP-6
LOOKING EAST AT DOWNSTREAM DISCHARGE OF 60
ML HDPE LINED LANDFILL RUNOFF/LEACHATE CHANNEL

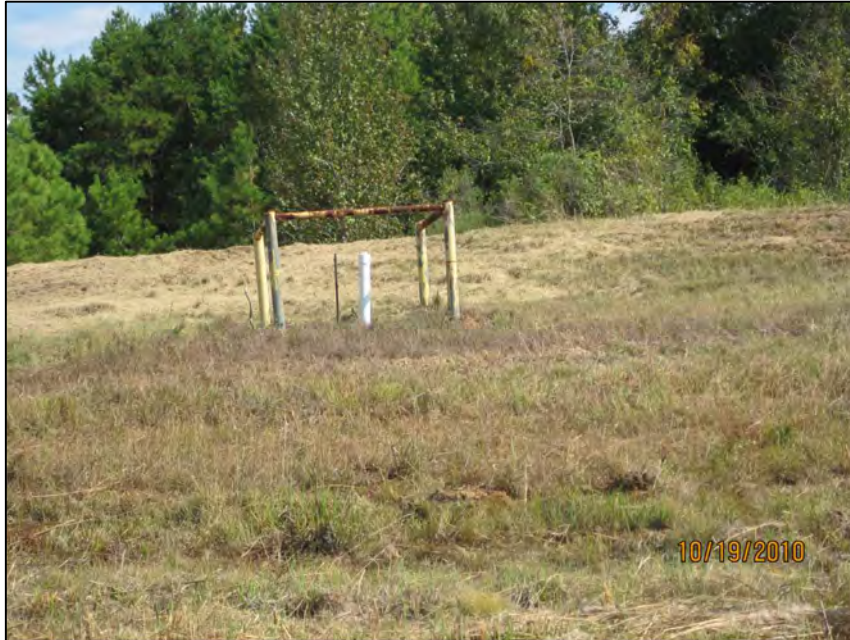
LRP-7
MONITORING WELL ADJACENT TO
NORTHEASTERN CORNER OF POND

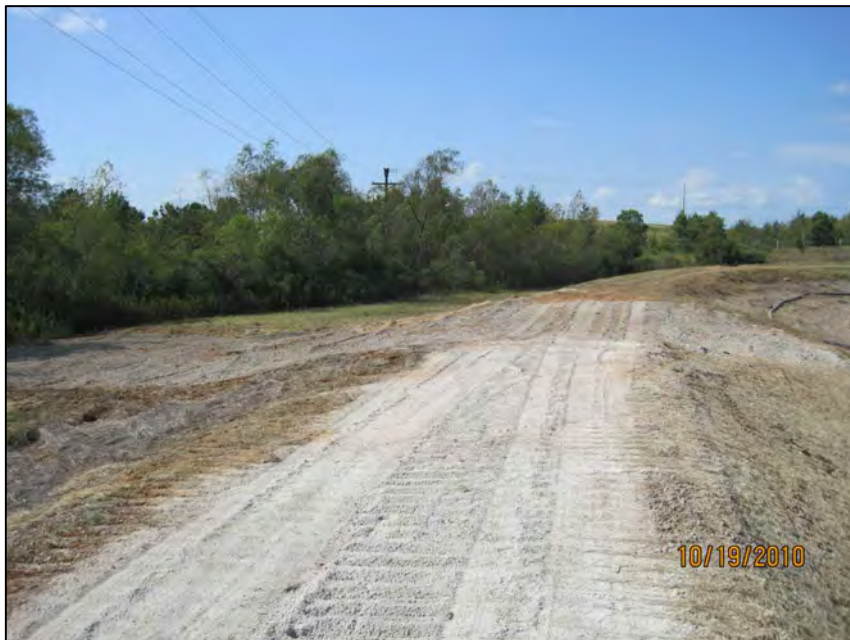
An emergency, earthen spillway was noted to exist to the west of the main discharge pipe, as shown on Photo LRP-8.

LRP-8
LOOKING WEST FROM CREST AT
UNLINED EARTHEN EMERGENCY SPILLWAY
